Technical Tips and Tricks | AlliedWare Plus™ Managed Layer 3 Switches

This document contains useful technical tips and tricks for AlliedWare Plus Managed Layer 3 switches.

SwitchBlade™ x908
x600-24Ts
x600-24Ts-POE
x600-24Ts/XP
x600-48Ts
x600-48Ts/XP
x900-12XT/S
x900-24XT
x900-24XT-N
x900-24XS

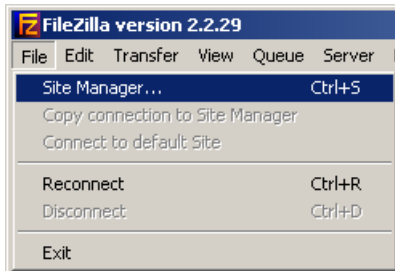
Within Filezilla, you need to create an FTP site definition that uses SFTP to connect to your switch.

1. Select **File > Site Manager...**

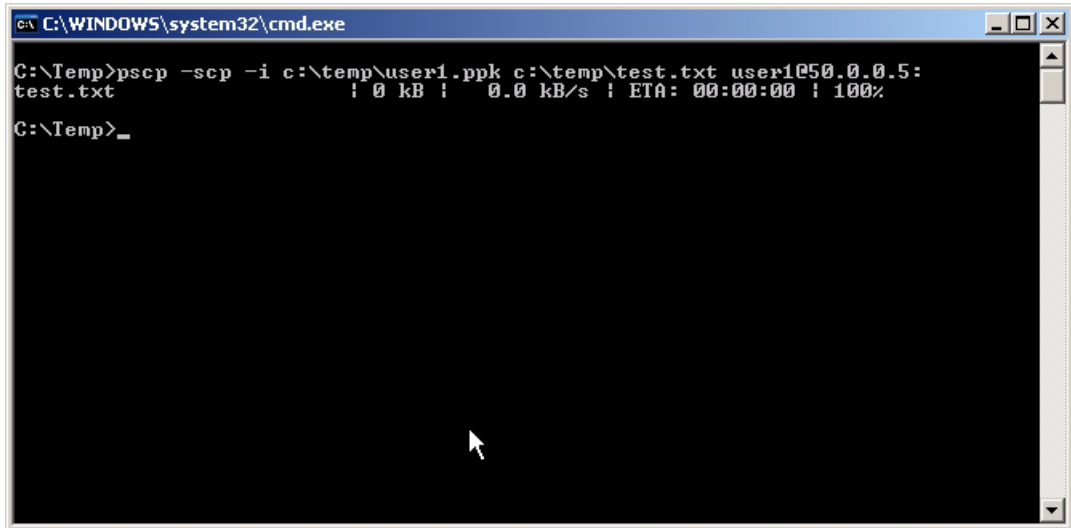
2. Navigate to the folder which contains the pscp.exe program and the public and private key files
3. Use pscp.exe to login and copy a file onto the switch, as shown below:

The command:

```
pscp -scp -i c:\temp\user1.ppk c:\temp\test.txt user1@50.0.0.5:
```

Parameter	Description
-scp	tells the program to use SCP instead of SFTP
-i c:\temp\user1.ppk	the location of the private key file
c:\temp\test.txt	the location of the file to be copied to the switch
user1@50.0.0.5:	the SSH username, at the IP address of the switch

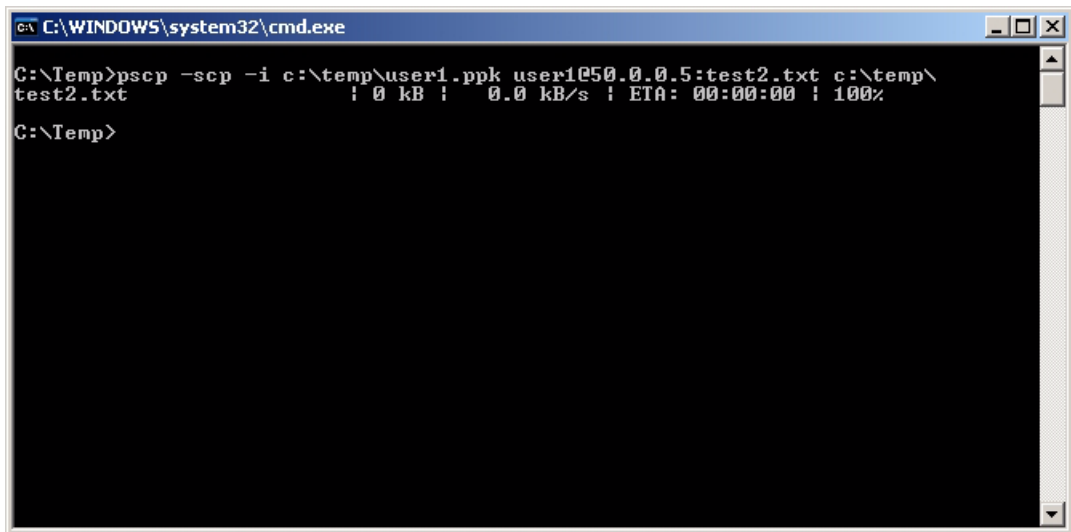
4. Use pscp.exe to login and copy a file from the switch to the client:

```
C:\WINDOWS\system32\cmd.exe
C:\Temp>pscp -scp -i c:\temp\user1.ppk user1@50.0.0.5:test2.txt c:\temp\
test2.txt

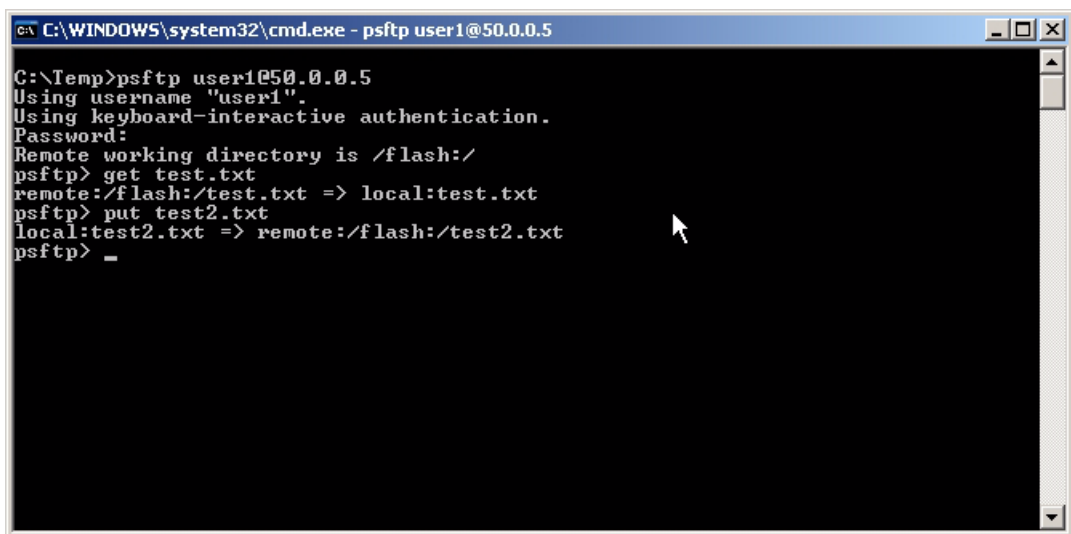
1. Login to the switch using psftp.exe

```
C:\WINDOWS\system32\cmd.exe - psftp user1@50.0.0.5
C:\Temp>psftp user1@50.0.0.5
Using username "user1".
Using keyboard-interactive authentication.
Password:
Remote working directory is /flash:/
psftp> get test.txt
remote:/flash:/test.txt => local:test.txt
psftp> put test2.txt
local:test2.txt => remote:/flash:/test2.txt
psftp> _
```

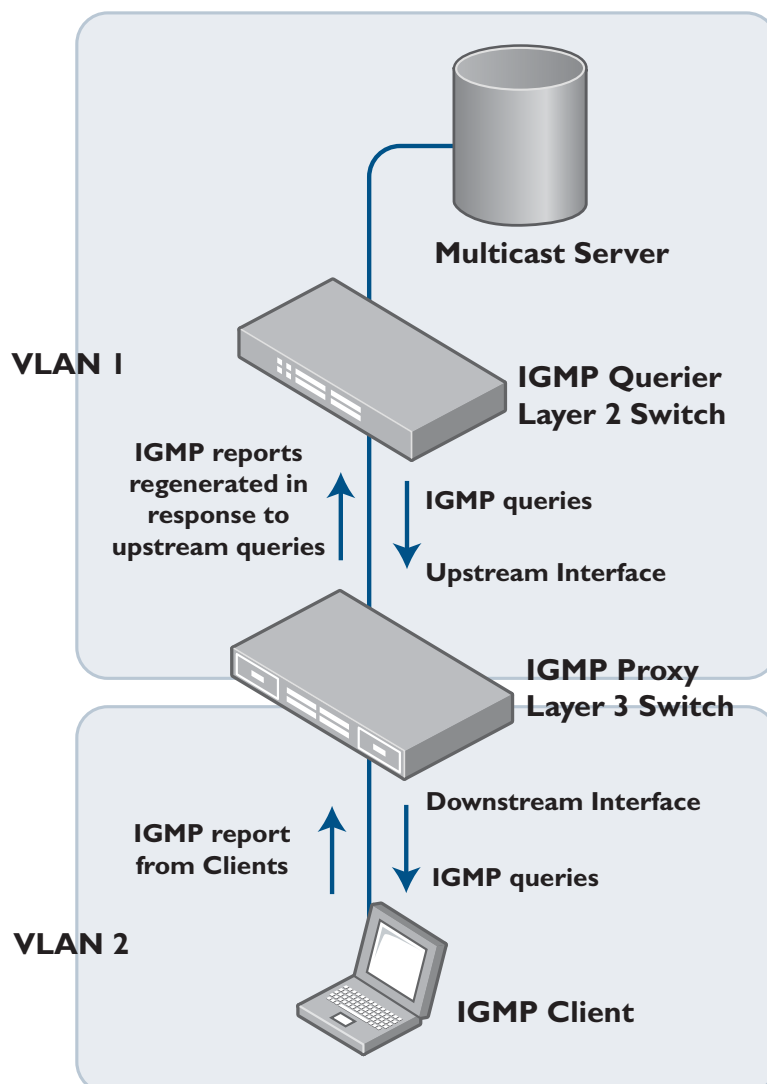
- Multicast Server - source of multicast streams
- IGMP Querier - one for each L2 broadcast domain
- IGMP Proxy Upstream Interface - emulates client behaviour
- IGMP Proxy Downstream Interface - may also be downstream IGMP Querier
- IGMP Client

This diagram shows the correct IGMP proxy roles:

To resolve this issue, you must ensure that the correct IGMP roles are given to the correct devices. In cases where the issue is experienced, usually the upstream interface of the IGMP proxy has also been configured as IGMP Querier on the same interface. This combination causes a conflict between the two roles.

However, as previously discussed, the issue arises if the **upstream** interface of the IGMP Proxy device has been wrongly configured as Querier **as well as** Upstream Proxy interface, and if that interface becomes the elected Querier, then step 5 above causes a conflict. The IGMP Proxy does not hear itself as querier, and therefore does not send reports.
